**Flood Control Project Maintenance**  
**2019 Structure Summary Report**  
**Overall Unit and Item Ratings**

## DWR Sutter Maintenance Yard

### Butte Slough Drainage Structure

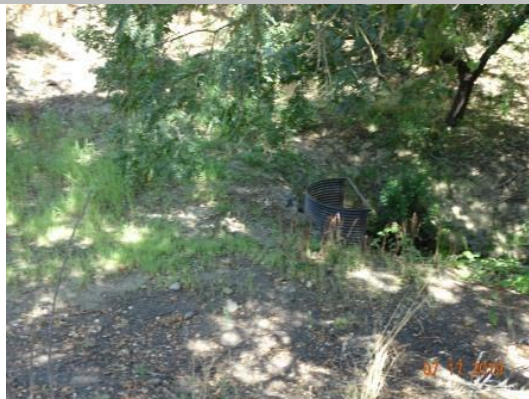
Photo 1 of 7 : ST\_2019\_NA0060\_38\_1\_20190718\_00010.jpg

View of the Butte Slough Drainage Structure on the landside.

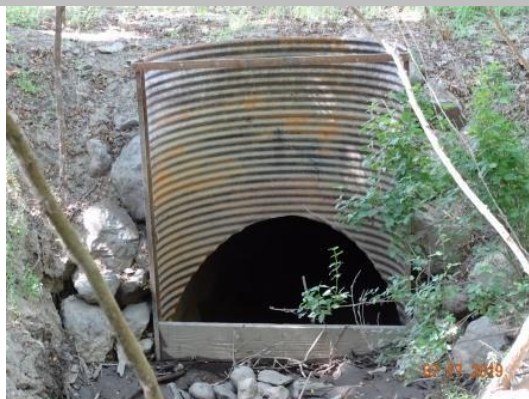
Photo 2 of 7 : ST\_2019\_NA0060\_38\_1\_20190718\_00011.jpg

Up-close view of the Butte Slough Drainage Structure on the landside.

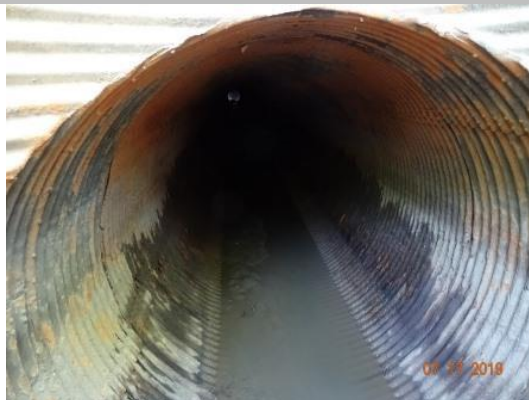
Photo 3 of 7 : ST\_2019\_NA0060\_38\_1\_20190718\_00012.jpg

View of the pipe from the landside.

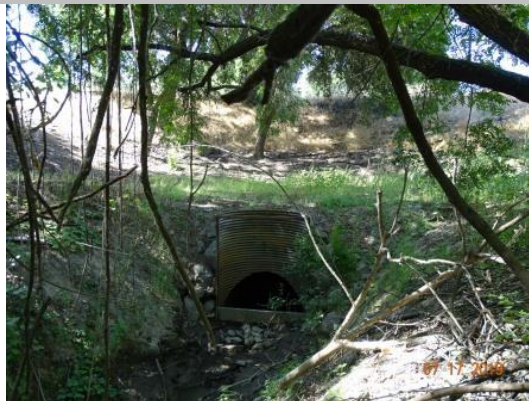
Photo 4 of 7 : ST\_2019\_NA0060\_38\_1\_20190718\_00013.jpg

View of the centerline alignment from the landside, looking at the levee.

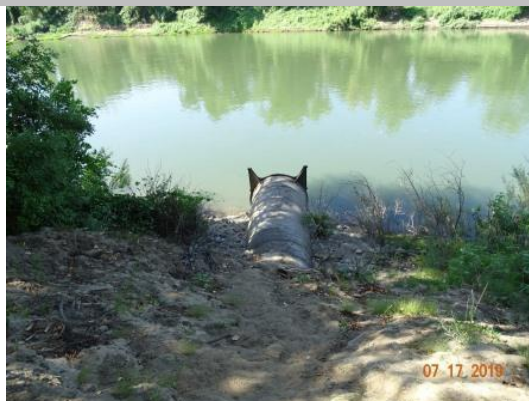
Photo 5 of 7 : ST\_2019\_NA0060\_38\_1\_20190718\_00014.jpg

View of the Butte Slough Drainage Structure on the waterside.

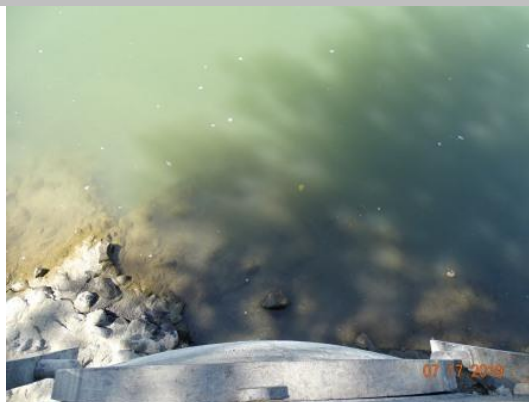
Photo 6 of 7 : ST\_2019\_NA0060\_38\_1\_20190718\_00015.jpg

Top view of the outfall flap gate.

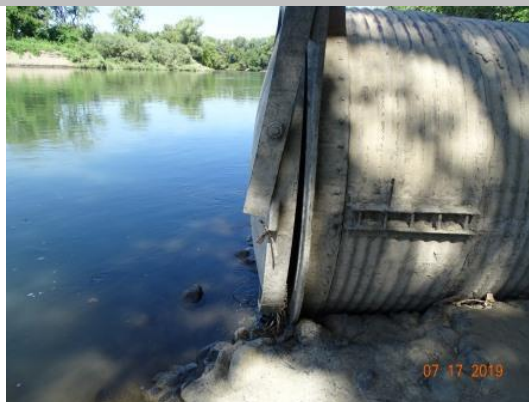
Photo 1 of 1 : ST\_2019\_NA0060\_38\_11\_20190718\_00017.jpg

View of the flap gate.

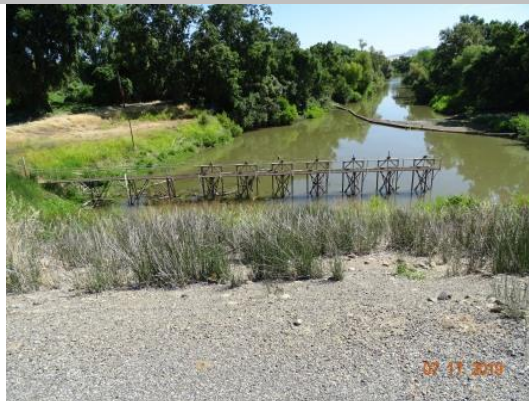
Photo 1 of 8 : ST\_2019\_NA0060\_42\_1\_20190718\_00014.jpg

View of the Butte Slough Outfall Structure from the landside levee crown.

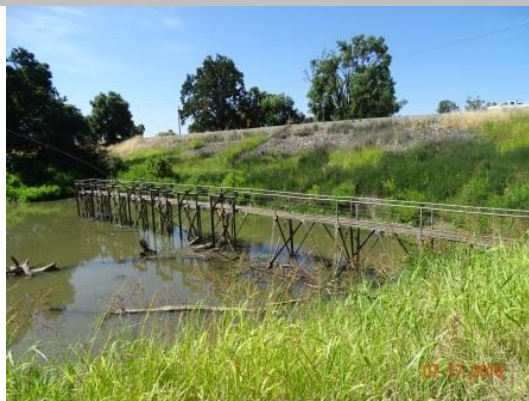
Photo 2 of 8 : ST\_2019\_NA0060\_42\_1\_20190718\_00011.jpg

Another view of the Butte Slough Outfall Structure.

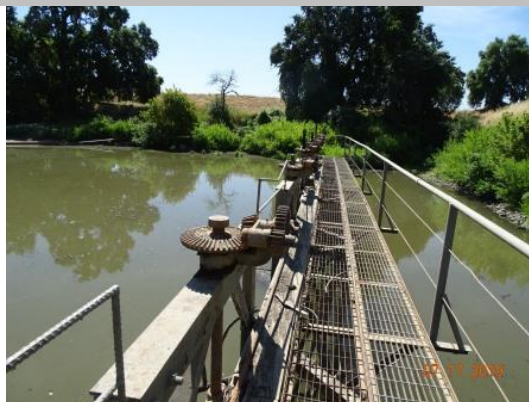
Photo 3 of 8 : ST\_2019\_NA0060\_42\_1\_20190718\_00013.jpg

View of the platform and mechanical gate operation mechanism.

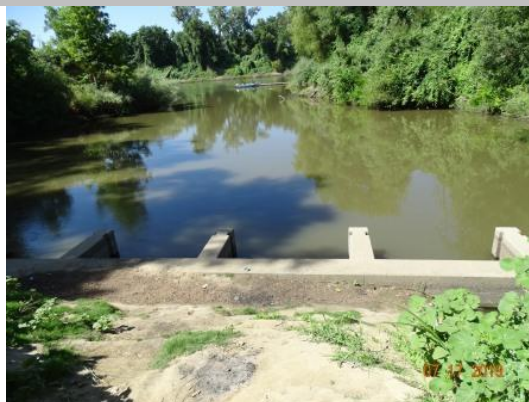
Photo 6 of 8 : ST\_2019\_NA0060\_42\_1\_20190718\_00019.jpg

View of the Butte Slough Outfall Structure headwall on the waterside of the levee.

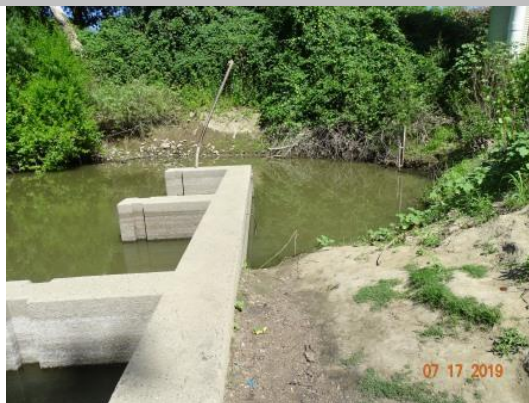
Photo 7 of 8 : ST\_2019\_NA0060\_42\_1\_20190718\_00016.jpg

View of the right side of the structure's headwall.

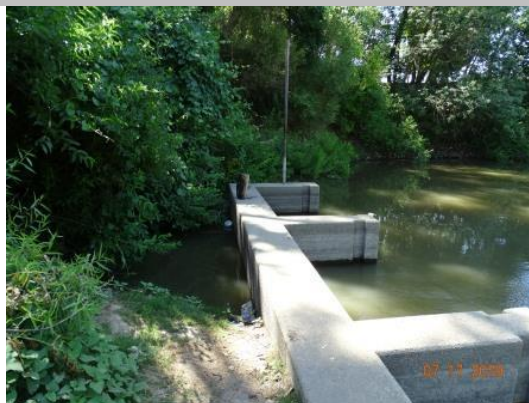
Photo 8 of 8 : ST\_2019\_NA0060\_42\_1\_20190718\_00017.jpg

View of the left side of the structure's headwall.

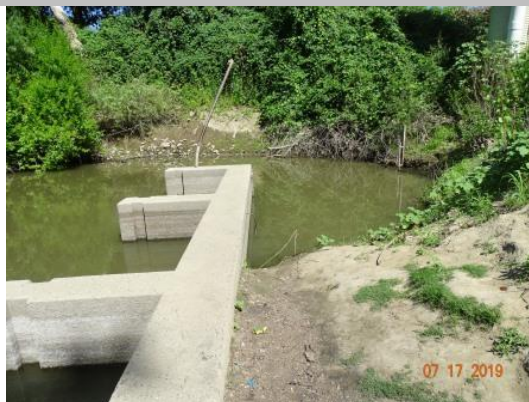
Photo 1 of 2 : ST\_2019\_NA0060\_42\_4\_20190718\_00021.jpg

LM Start	0.00	Rating **	M	Issue No.	4
LM End	0.00	Issue Type +	Ma	Location *	
Category	Structures & Concrete Lined Channels	GPS Latitude/Longitude			
		Start		End	
Item	Erosion / Bank Caving	39.194972 °		39.194972 °	
		-121.936088 °		-121.936088 °	
DWR ID	DWR_NA0060_42_t_2012_4				
Action/Comments					
Inspector Comments: The active erosion at the outlet's headwall is progressing from year to year. The erosion needs to be addressed.

View of the active erosion around the rightside of the headwall.

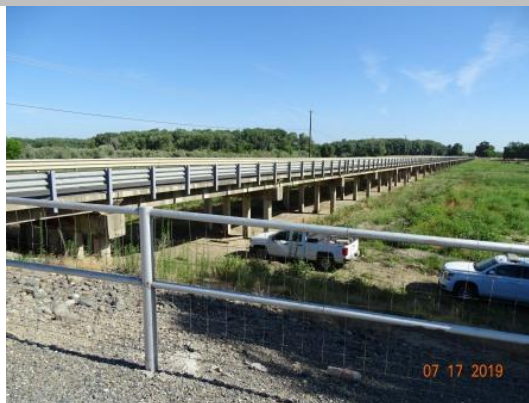
Photo 1 of 9 : ST\_2019\_NA0060\_55\_1\_20190718\_00018.jpg

View of the weir from the right bank looking upstream.

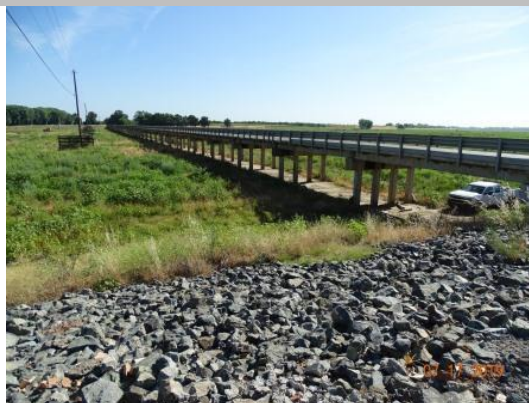
Photo 2 of 9 : ST\_2019\_NA0060\_55\_1\_20190718\_00019.jpg

View of the weir from the right bank looking downstream.

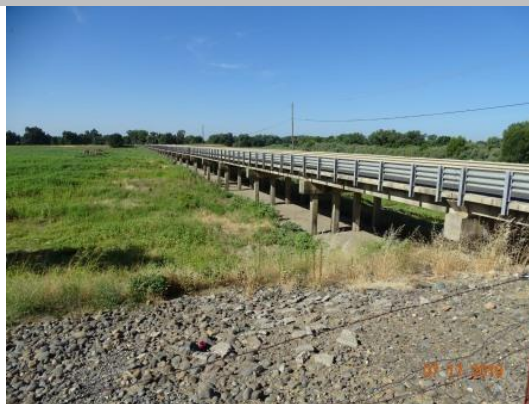
Photo 3 of 9 : ST\_2019\_NA0060\_55\_1\_20190718\_00020.jpg

View of the weir from the left bank looking upstream.

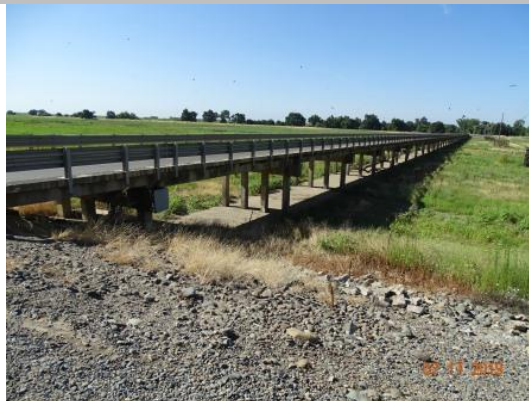
Photo 4 of 9 : ST\_2019\_NA0060\_55\_1\_20190718\_00021.jpg

View of the weir from the left bank looking downstream.

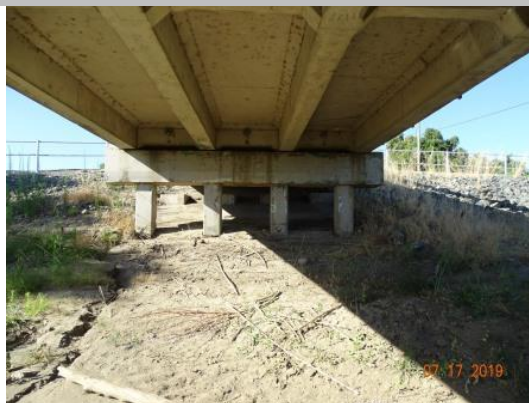
Photo 5 of 9 : ST\_2019\_NA0060\_55\_1\_20190718\_00013.jpg

View of the weir's right bank abutment.

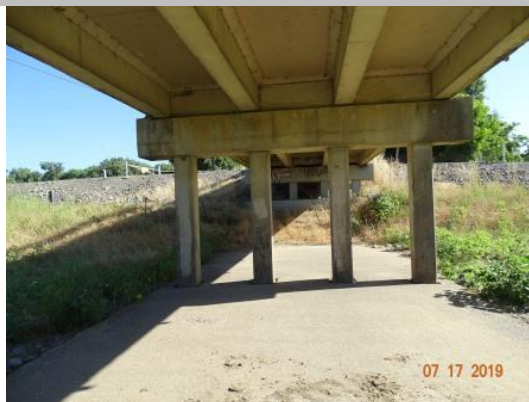
Photo 6 of 9 : ST\_2019\_NA0060\_55\_1\_20190718\_00016.jpg

View of the weir's left bank abutment.

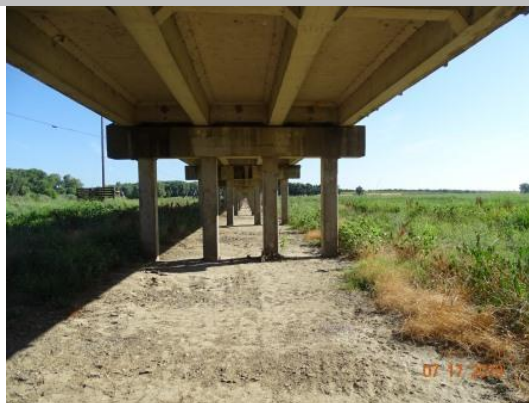
Photo 7 of 9 : ST\_2019\_NA0060\_55\_1\_20190718\_00012.jpg

Typical view of the weir.

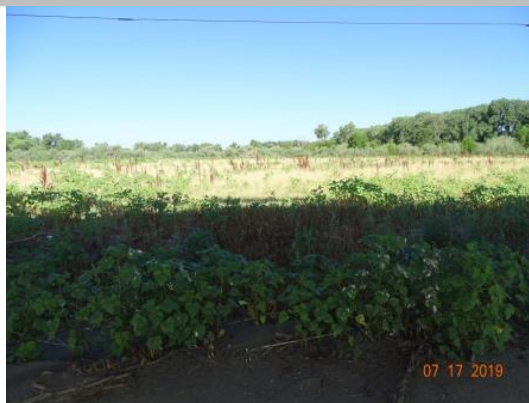
Photo 8 of 9 : ST\_2019\_NA0060\_55\_1\_20190718\_00014.jpg

Typical upstream view from the weir.

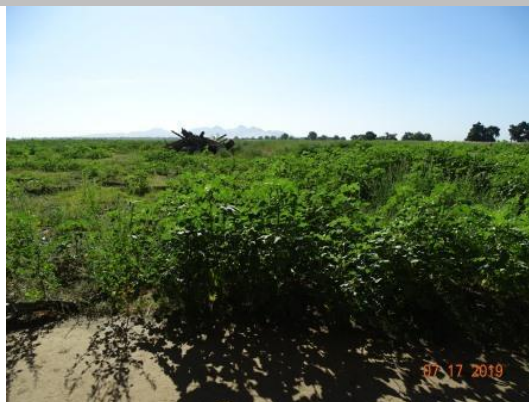
Photo 9 of 9 : ST\_2019\_NA0060\_55\_1\_20190718\_00015.jpg

Typical downstream view from the weir.

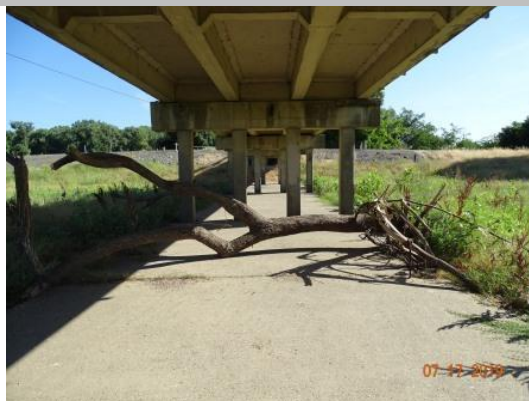
Photo 2 of 2 : ST\_2019\_NA0060\_55\_2\_20190718\_00023.jpg

View of a large tree in the weir.

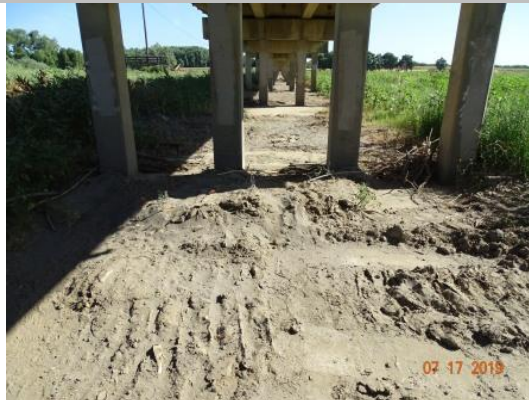
Photo 1 of 1 : ST\_2019\_NA0060\_55\_3\_20190718\_00024.jpg

LM Start	0.00	Rating **	M	Issue No.	3
LM End	0.00	Issue Type +	Ma	Location *	
Category	Structures & Concrete Lined Channels			GPS Latitude/Longitude	
				Start	End
Item	Shoaling / Sedimentation			39.232135 °	39.232135 °
				-121.996253 °	-121.996253 °
DWR ID	DWR_NA0060_55_t_2012_3				
Action/Comments					
Inspector Comments: Sedimentation is present. Most of the sedimentation buildup is within the right half of the weir.

View of the sediment buildup.

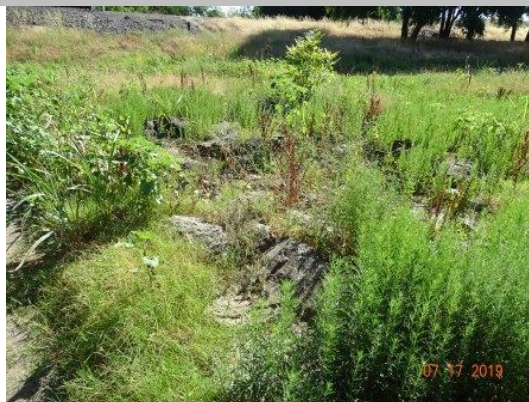
Photo 1 of 1 : ST\_2019\_NA0060\_55\_5\_20190718\_00025.jpg

LM Start	0.00	Rating **	A	Issue No.	5	
LM End	0.00	Issue Type +	Ma	Location *		
Category	Structures & Concrete Lined Channels			GPS Latitude/Longitude		
				Start		End
Item	Revetments			39.232135 °		39.232135 °
				-121.996253 °		-121.996253 °
DWR ID	DWR_NA0060_55_t_2012_5					
Action/Comments						
Inspector Comments: The riprap is present. Vegetation within the ripraped area should be cleared.

View of the riprap on the downstream side of the weir.

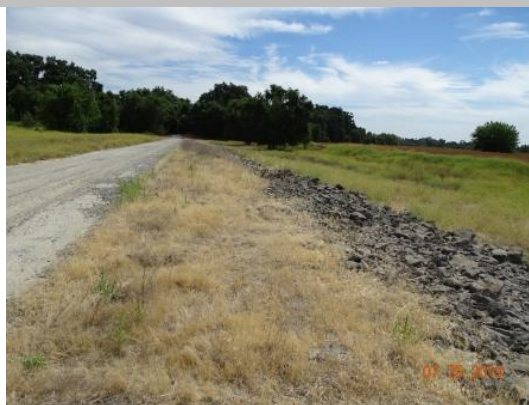
Photo 2 of 2 : ST\_2019\_NA0060\_225\_1\_20190726\_00006.jpg

Typical view of the structure.

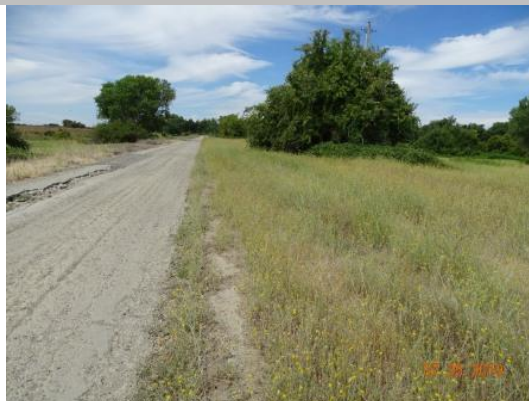
Photo 1 of 2 : ST\_2019\_NA0060\_225\_2\_20190726\_00007.jpg

View of the vegetation on the upstream of the weir.

LM Start	0.00	Rating **	M	Issue No.	2
LM End	0.00	Issue Type +	Ma	Location *	LS
Category	Structures & Concrete Lined Channels			GPS Latitude/Longitude	
				Start	End
Item	Vegetation & Obstructions			39.569247 °	39.569247 °
				-121.982569 °	-121.982569 °
DWR ID	DWR_NA0060_225_t_2013_2				
Action/Comments					
Inspector Comments: Spray the vegetation for approximately 20 feet on both sides of the weir.

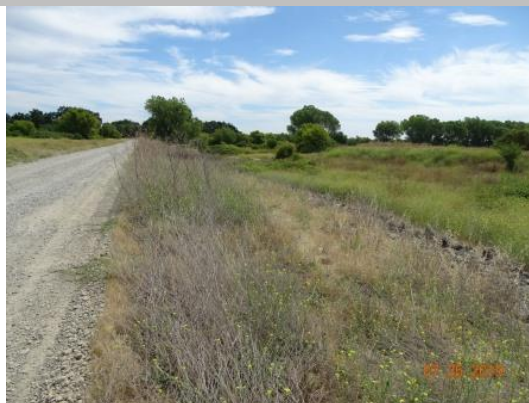
Photo 2 of 2 : ST\_2019\_NA0060\_225\_2\_20190726\_00009.jpg

View of the vegetation on the downstream of the weir.

LM Start	0.00	Rating **	M	Issue No.	2 (cont)	
LM End	0.00	Issue Type +	Ma	Location *	LS	
Category	Structures & Concrete Lined Channels			GPS Latitude/Longitude		
				Start		End
Item	Vegetation & Obstructions			39.569247 °		39.569247 °
				-121.982569 °		-121.982569 °
DWR ID	DWR_NA0060_225_t_2013_2					
Action/Comments						
Inspector Comments: Spray the vegetation for approximately 20 feet on both sides of the weir.

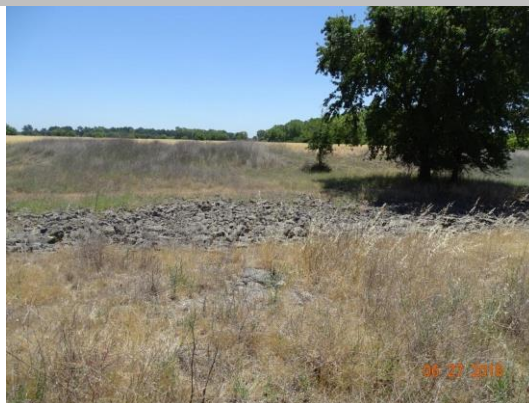
Photo 1 of 1 : ST\_2019\_NA0060\_225\_5\_20190521\_00004.jpg

View of the existing revetment on the downstream of the weir.

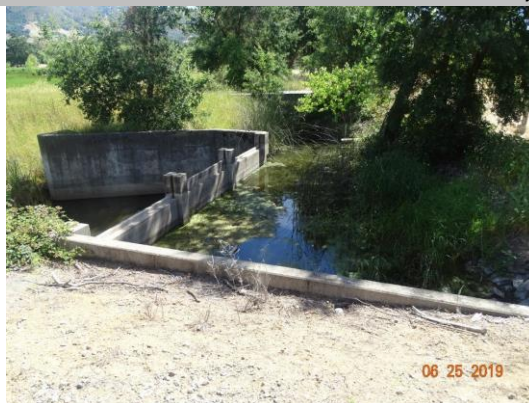
Photo 1 of 1 : ST\_2019\_NA0060\_7\_1\_20190627\_00007.jpg

LM Start	0.00	Rating **	N	Issue No.	1
LM End	0.00	Issue Type +	Ma	Location *	
Category	Structures & Concrete Lined Channels			GPS Latitude/Longitude	
				Start	End
Item	Photo Documentation			39.126317 °	39.126317 °
				-122.882733 °	-122.882733 °
DWR ID	DWR_NA0009_7_t_2012_1				
Action/Comments					
Inspector Comments: Highland Canal Diversion Weir works as a control point that diverts water through a culvert during high water season.

View of the weir. Summer 2019.

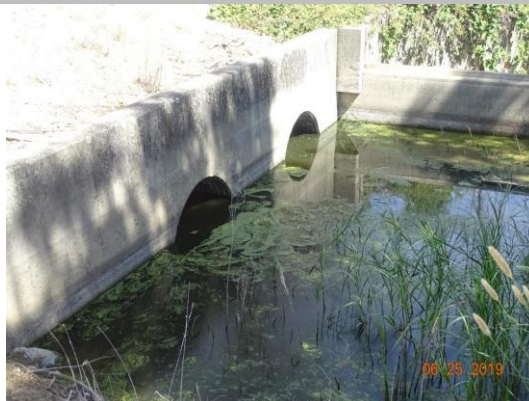
Photo 1 of 2 : ST\_2019\_NA0060\_7\_7\_20190627\_00009.jpg

LM Start	0.00	Rating **	M	Issue No.	7
LM End	0.00	Issue Type +	Ma	Location *	
Category	Structures & Concrete Lined Channels			GPS Latitude/Longitude	
				Start	End
Item	Culverts: Inlets / Outlets			39.126317 °	39.126317 °
				-122.882733 °	-122.882733 °
DWR ID	DWR_NA0009_7_t_2012_7				
Action/Comments					
Inspector Comments: There is some debris in the culvert. The Sutter Yard confirmed they will remove it when the water levels decrease.

View of the inlets. Summer 2019.

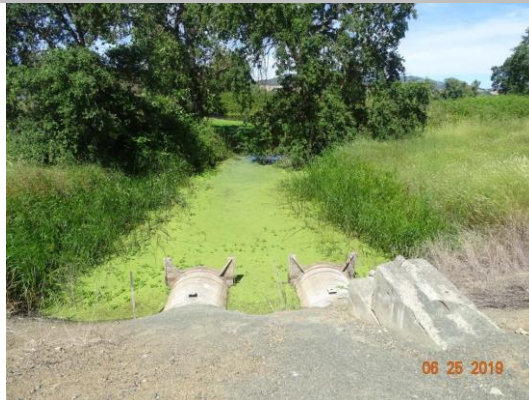
Photo 2 of 2 : ST\_2019\_NA0060\_7\_7\_20190627\_00010.jpg

View of the outlets. Summer 2019.

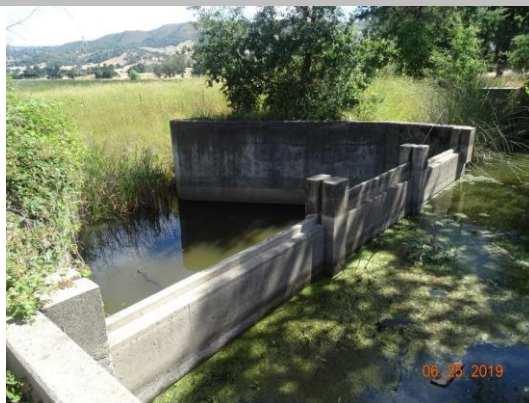
Photo 1 of 4 : ST\_2019\_NA0060\_7\_15\_20190701\_00011.jpg

LM Start	0.00	Rating **	A	Issue No.	15	
LM End	0.00	Issue Type +	Ma	Location *		
Category	Structures & Concrete Lined Channels			GPS Latitude/Longitude		
				Start	End	
Item	Concrete Surfaces			39.126317 °	39.126317 °	
				-122.882733 °	-122.882733 °	
DWR ID	DWR_NA0009_7_t_2012_15					
Action/Comments						
Inspector Comments: There was some minor cracking and scaling on the concrete structure do to its age, but this does not appear to threaten its structural integrity.

View of the concrete weir structure. Summer 2019.

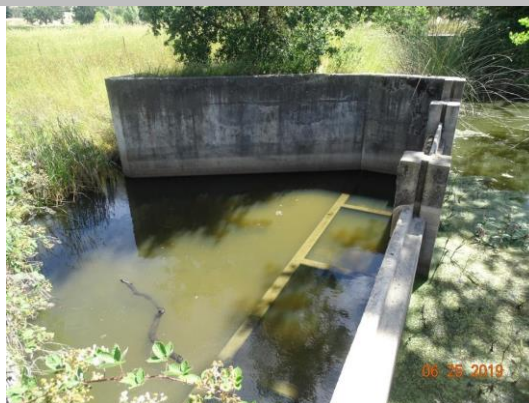
Photo 2 of 4 : ST\_2019\_NA0060\_7\_15\_20190701\_00012.jpg

View of the weir stilling basin. Summer 2019.

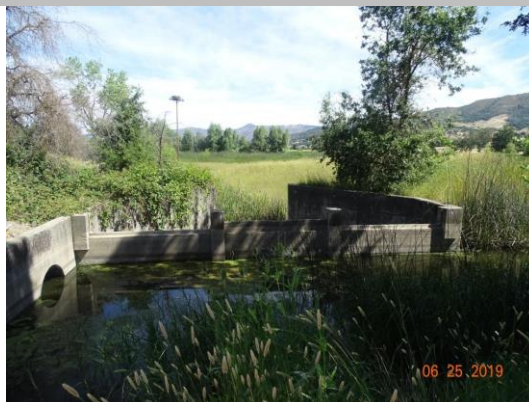
Photo 3 of 4 : ST\_2019\_NA0060\_7\_15\_20190701\_00013.jpg

View of the weir structure facing towards the downstream relief channel. Summer 2019.

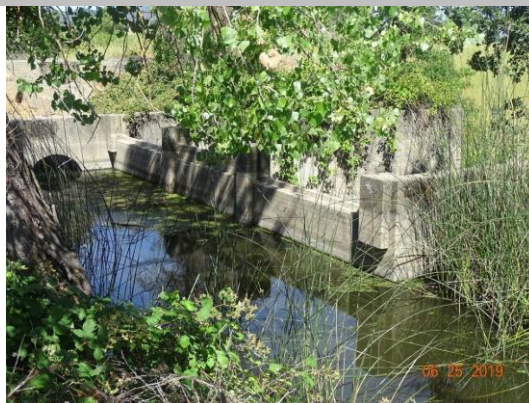
Photo 4 of 4 : ST\_2019\_NA0060\_7\_15\_20190701\_00014.jpg

LM Start	0.00	Rating **	A	Issue No.	15 (cont)	
LM End	0.00	Issue Type +	Ma	Location *		
Category	Structures & Concrete Lined Channels			GPS Latitude/Longitude		
				Start		End
Item	Concrete Surfaces			39.126317 °		39.126317 °
				-122.882733 °		-122.882733 °
DWR ID	DWR_NA0009_7_t_2012_15					
Action/Comments						
Inspector Comments: There was some minor cracking and scaling on the concrete structure do to its age, but this does not appear to threaten its structural integrity.

View of the structure facing towards the inlets. Summer 2019.

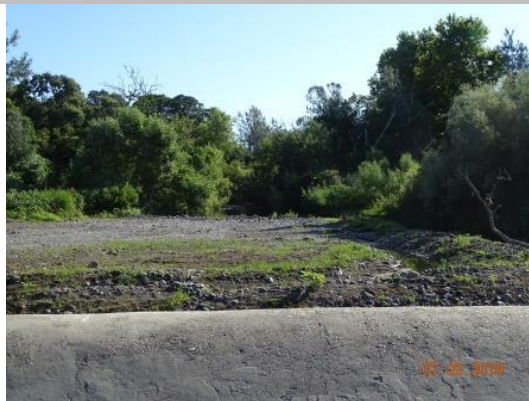
Photo 1 of 3 : ST\_2019\_NA0060\_9\_2\_20190710\_00026.jpg

This is a view looking upstream at the vegetation from the weir, 2019.

LM Start	0.00	Rating **	A	Issue No.	2
LM End	0.00	Issue Type +	Ma	Location *	
Category	Structures & Concrete Lined Channels			GPS Latitude/Longitude	
				Start	End
Item	Vegetation & Obstructions			39.733555 °	39.733555 °
				-121.771772 °	-121.771772 °
DWR ID	DWR_NA0060_9_t_2012_2				
Action/Comments					
Inspector Comments: Any unwanted vegetation should be removed before winter, 2019.

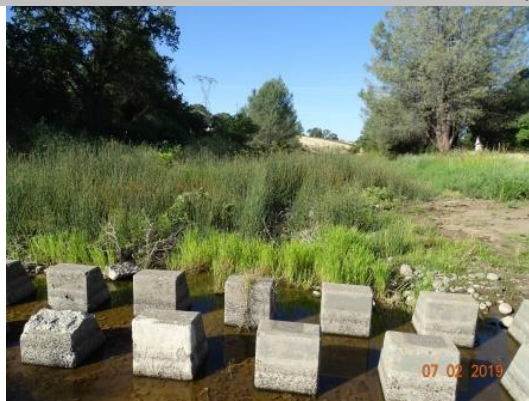
Photo 2 of 3 : ST\_2019\_NA0060\_9\_2\_20190710\_00027.jpg

This is a view looking downstream from the weir at the vegetation, 2019.

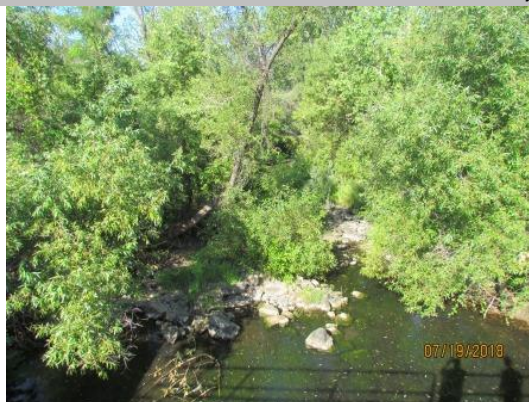
Photo 3 of 3 : ST\_2019\_NA0060\_9\_2\_20190701\_00008.jpg

This is a view looking downstream from the control structure at the vegetation, 2018.

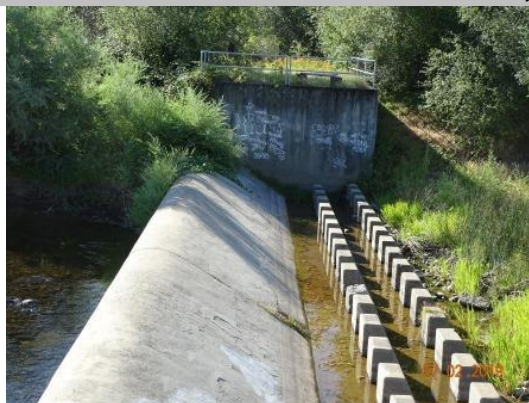
Photo 1 of 2 : ST\_2019\_NA0060\_9\_6\_20190710\_00028.jpg

LM Start	0.00	Rating **	A	Issue No.	6
LM End	0.00	Issue Type +	Ma	Location *	
Category	Structures & Concrete Lined Channels			GPS Latitude/Longitude	
				Start	End
Item	Encroachments			39.733555 °	39.733555 °
				-121.771772 °	-121.771772 °
DWR ID	DWR_NA0060_9_t_2012_6				
Action/Comments					
Inspector Comments: Wood debris encroachment in the weir has been removed, 2019.

View of the weir with the removed debris, 2019.

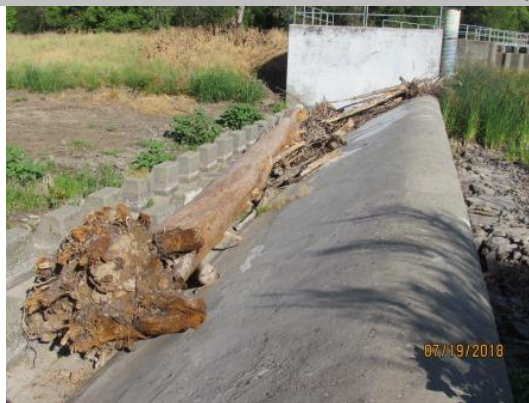
Photo 2 of 2 : ST\_2019\_NA0060\_9\_6\_20190701\_00011.jpg

View of a few logs trapped in the weir, 2018.

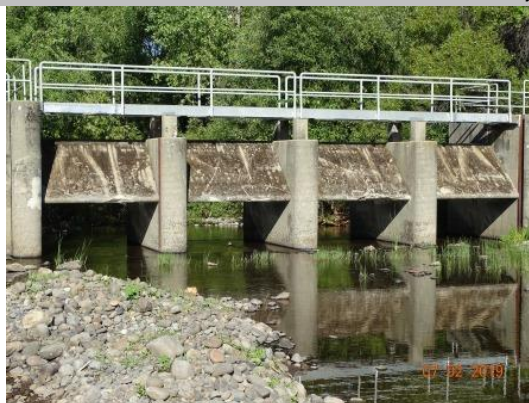
Photo 1 of 2 : ST\_2019\_NA0060\_9\_7\_20190710\_00031.jpg

LM Start	0.00	Rating **	A	Issue No.	7
LM End	0.00	Issue Type +	Ma	Location *	
Category	Structures & Concrete Lined Channels			GPS Latitude/Longitude	
				Start	End
Item	Culverts: Inlets / Outlets			39.733555 °	39.733555 °
				-121.771772 °	-121.771772 °
DWR ID	DWR_NA0060_9_t_2012_7				
Action/Comments					
Inspector Comments: Inlets and outlets are clear of obstructions, 2019.

View of inlets clear of obstructions, 2019.

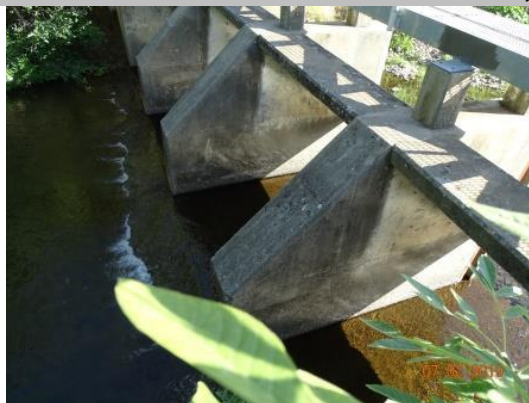
Photo 2 of 2 : ST\_2019\_NA0060\_9\_7\_20190710\_00030.jpg

View of outlets clear of obstructions, 2019.

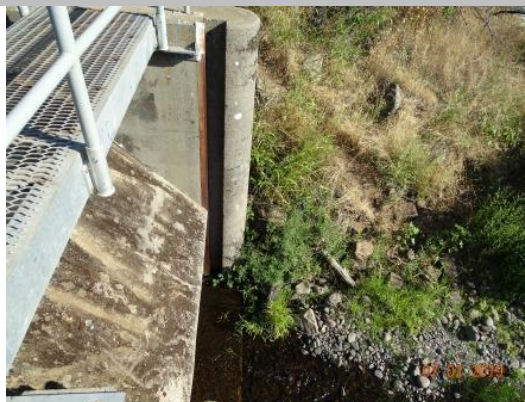
Photo 1 of 2 : ST\_2019\_NA0060\_9\_12\_20190710\_00032.jpg

LM Start	0.00	Rating **	A	Issue No.	12
LM End	0.00	Issue Type +	Ma	Location *	
Category	Structures & Concrete Lined Channels	GPS Latitude/Longitude			
		Start	End		
Item	Sluice/Slide Gates	39.733555 °		39.733555 °	
		-121.771772 °		-121.771772 °	
DWR ID	DWR_NA0060_9_t_2012_12				
Action/Comments					
Inspector Comments: The two sluice gates on either end of the control structure are in good condition, 2019.

View of the two sluice gates on either end of the control structure, 2019.

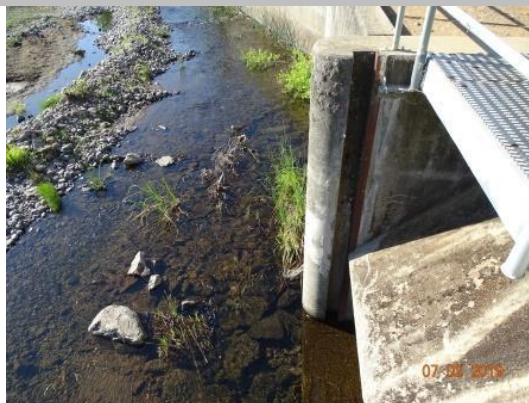
Photo 2 of 2 : ST\_2019\_NA0060\_9\_12\_20190710\_00033.jpg

View of the two sluice gates on either end of the control structure, 2019.

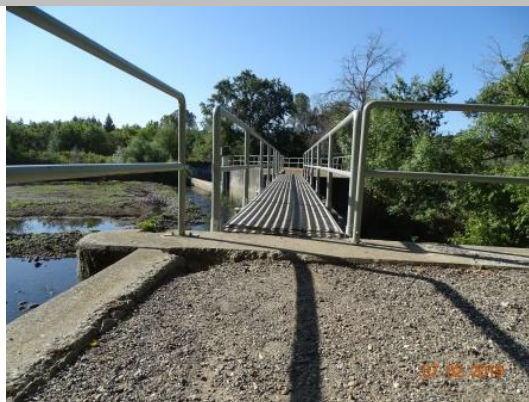
Photo 1 of 2 : ST\_2019\_NA0060\_9\_23\_20190710\_00037.jpg

LM Start	0.00	Rating **	A	Issue No.	23
LM End	0.00	Issue Type +	Ma	Location *	
Category	Structures & Concrete Lined Channels			GPS Latitude/Longitude	
				Start	End
Item	Safety			39.733555 °	39.733555 °
				-121.771772 °	-121.771772 °
DWR ID	DWR_NA0060_9_t_2012_23				
Action/Comments					
Inspector Comments: Hand rails are installed and are in good condition, 2019.

Hand rails are installed and are in good condition, 2019.

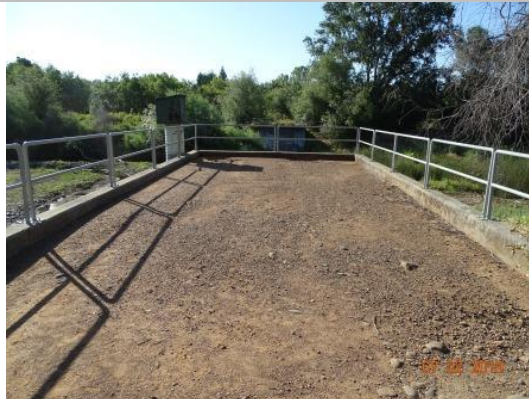
Photo 2 of 2 : ST\_2019\_NA0060\_9\_23\_20190710\_00035.jpg

Hand rails are installed and are in good condition, 2019.

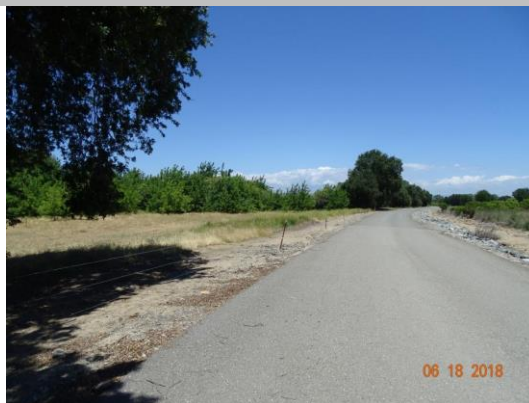
Photo 1 of 3 : ST\_2019\_NA0060\_228\_2\_20190521\_00002.jpg

View of the vegetation on the upstream side of the weir.

LM Start	0.00	Rating **	A	Issue No.	2
LM End	0.00	Issue Type +	Ma	Location *	WS
Category	Structures & Concrete Lined Channels			GPS Latitude/Longitude	
				Start	End
Item	Vegetation & Obstructions			39.674690 °	39.674690 °
				-121.947013 °	-121.947013 °
DWR ID	DWR_NA0014_228_t_2013_2				
Action/Comments					
Inspector Comments: The scattered piles of tree branches should be removed.

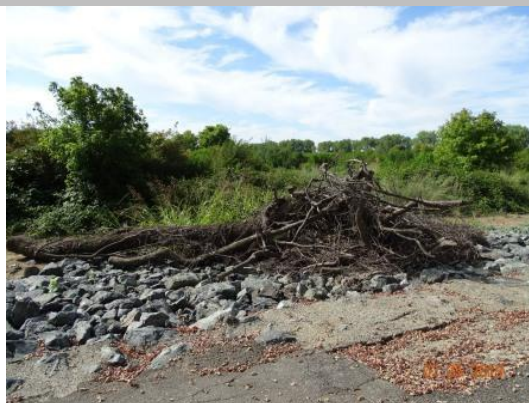
Photo 2 of 3 : ST\_2019\_NA0060\_228\_2\_20190726\_00008.jpg

View of the pile of tree branches; 0.1 miles from the structure's left bank.

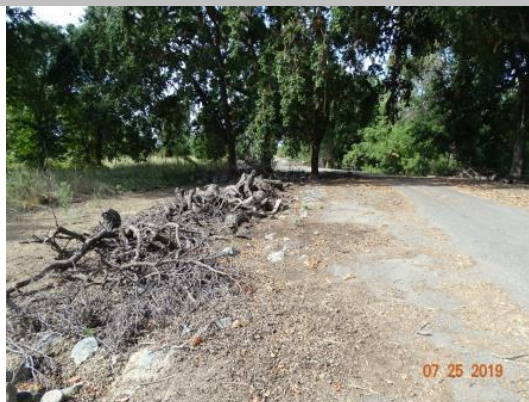
Photo 3 of 3 : ST\_2019\_NA0060\_228\_2\_20190726\_00009.jpg

View of another pile of tree branches; 0.6 miles from the structure's left bank.

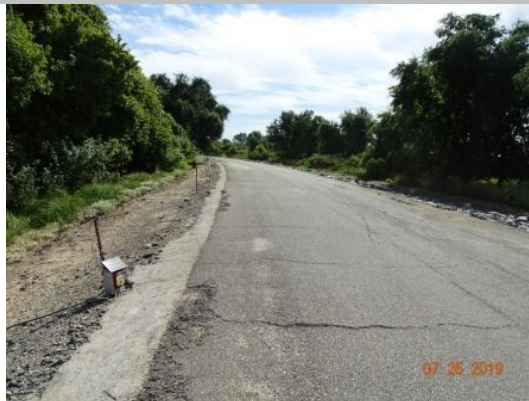
Photo 1 of 1 : ST\_2019\_NA0060\_228\_6\_20190731\_00016.jpg

LM Start	0.00	Rating **	M	Issue No.	6
LM End	0.00	Issue Type +	En	Location *	WS
Category	Structures & Concrete Lined Channels			GPS Latitude/Longitude	
				Start	End
Item	Encroachments			39.674690 °	39.674690 °
				-121.947010 °	-121.947010 °
DWR ID	DWR_NA0014_228_t _ 2013_6				
Action/Comments

View of the electrical wire fence encroachment on the upstream side of the structure.

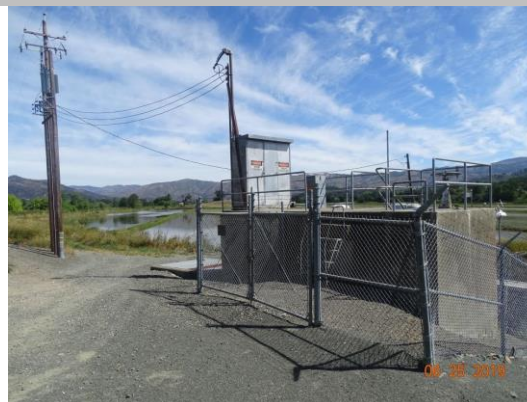
Photo 1 of 3 : ST\_2019\_NA0060\_17\_3\_20190701\_00013.jpg

LM Start	0.00	Rating **	M	Issue No.	3
LM End	0.00	Issue Type +	Ma	Location *	
Category	Pump Stations			GPS Latitude/Longitude	
				Start	End
Item	Plant Building			39.142300 °	39.142300 °
				-122.902350 °	-122.902350 °
DWR ID	DWR_NA0060_17_t_2012_3				
Action/Comments					
Inspector Comments: The plant building was in good structural condition with no major cracks that could threaten the integrity of the building. However, the adjacent structure has some differential settlement that appears to be stable.

View of the pumping plant. Summer 2019.

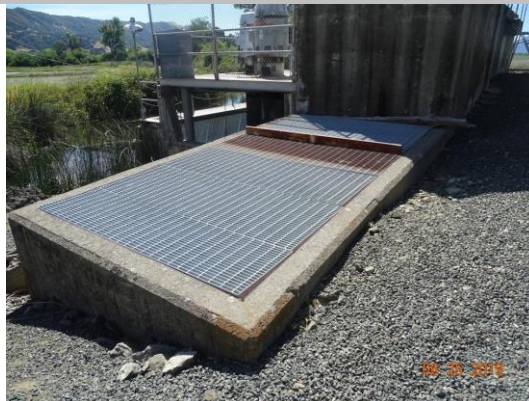
Photo 2 of 3 : ST\_2019\_NA0060\_17\_3\_20190701\_00014.jpg

LM Start	0.00	Rating **	M	Issue No.	3 (cont)	
LM End	0.00	Issue Type +	Ma	Location *		
Category	Pump Stations			GPS Latitude/Longitude		
				Start	End	
Item	Plant Building			39.142300 °	39.142300 °	
				-122.902350 °	-122.902350 °	
DWR ID	DWR_NA0060_17_t_2012_3					
Action/Comments						
Inspector Comments: The plant building was in good structural condition with no major cracks that could threaten the integrity of the building. However, the adjacent structure has some differential settlement that appears to be stable.

View of adjacent structure. Summer 2019.

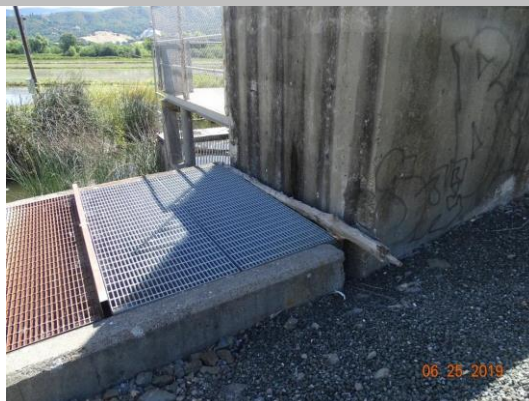
Photo 3 of 3 : ST\_2019\_NA0060\_17\_3\_20190701\_00015.jpg

View of stabilized settlement on the adjacent structure. Summer 2019.

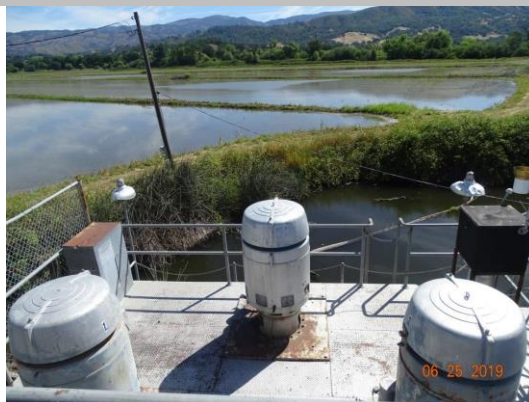
Photo 1 of 1 : ST\_2019\_NA0060\_17\_7\_20190701\_00016.jpg

LM Start	0.00	Rating **	A	Issue No.	7
LM End	0.00	Issue Type +	Ma	Location *	
Category	Pump Stations			GPS Latitude/Longitude	
				Start	End
Item	Pumps			39.142300 °	39.142300 °
				-122.902350 °	-122.902350 °
DWR ID	DWR_NA0060_17_t_2012_7				
Action/Comments					
Inspector Comments: The pumps appeared to be in good working condition and properly maintained including proper lubrication level.

View of the three pumps. Summer 2019.

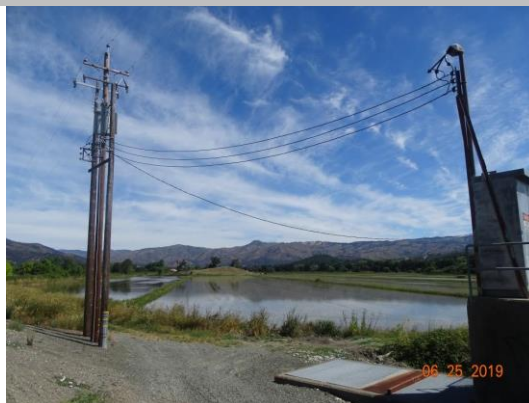
Photo 1 of 1 : ST\_2019\_NA0060\_17\_8\_20190701\_00017.jpg

LM Start	0.00	Rating **	A	Issue No.	8
LM End	0.00	Issue Type +	Ma	Location *	
Category	Pump Stations			GPS Latitude/Longitude	
				Start	End
Item	Power			39.142300 °	39.142300 °
				-122.902350 °	-122.902350 °
DWR ID	DWR_NA0060_17_t_2012_8				
Action/Comments					
Inspector Comments: The power source appears to be reliable and safe.

View of the powerlines that supply power to the plant. Summer 2019.

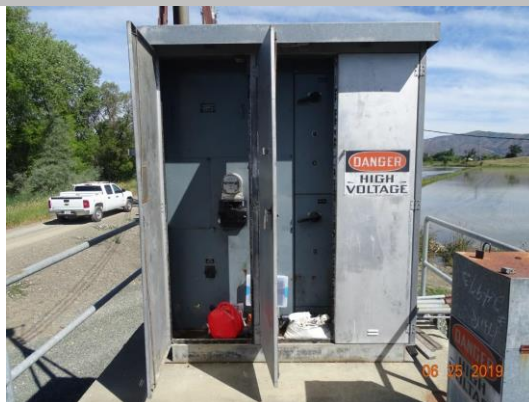
Photo 1 of 1 : ST\_2019\_NA0060\_17\_11\_20190701\_00018.jpg

LM Start	0.00	Rating **	A	Issue No.	11
LM End	0.00	Issue Type +	Ma	Location *	
Category	Pump Stations			GPS Latitude/Longitude	
				Start	End
Item	Pump Control Systems			39.142300 °	39.142300 °
				-122.902350 °	-122.902350 °
DWR ID	DWR_NA0060_17_t_2012_11				
Action/Comments					
Inspector Comments: The pump control systems appeared to be operational and free of damage.

View of the pump controls. Summer 2019.

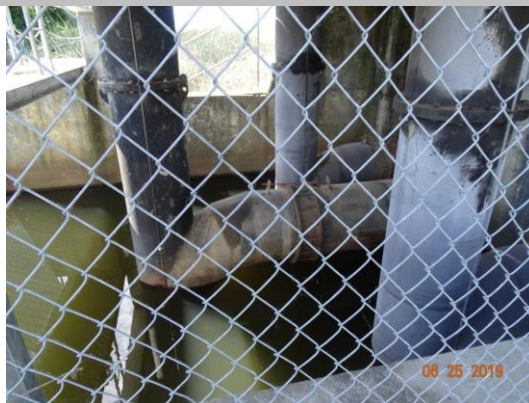
Photo 1 of 1 : ST\_2019\_NA0060\_17\_12\_20190701\_00019.jpg

LM Start	0.00	Rating **	A	Issue No.	12	
LM End	0.00	Issue Type +	Ma	Location *		
Category	Pump Stations			GPS Latitude/Longitude		
				Start		End
Item	Sumps/Wet Well			39.142300 °		39.142300 °
				-122.902350 °		-122.902350 °
DWR ID	DWR_NA0060_17_t_2013_12					
Action/Comments						
Inspector Comments: Wet wells were clear of debris.

View of the wet well and intake pipes. Summer 2019.

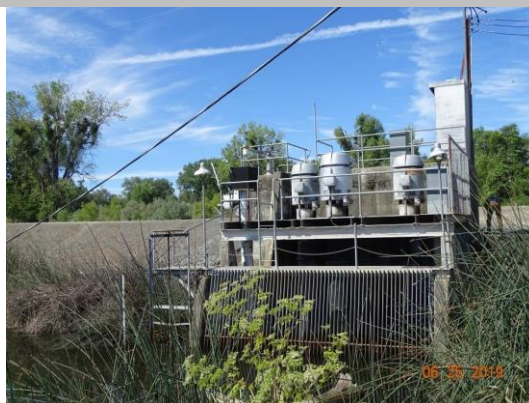
Photo 1 of 1 : ST\_2019\_NA0060\_17\_13\_20190701\_00020.jpg

LM Start	0.00	Rating **	A	Issue No.	13
LM End	0.00	Issue Type +	Ma	Location *	
Category	Pump Stations			GPS Latitude/Longitude	
				Start	End
Item	Trash Racks			39.142300 °	39.142300 °
				-122.902350 °	-122.902350 °
DWR ID	DWR_NA0060_17_t_2012_13				
Action/Comments					
Inspector Comments: Trash racks appeared to be in good condition and free of debris.

View of the trash racks. Summer 2019.

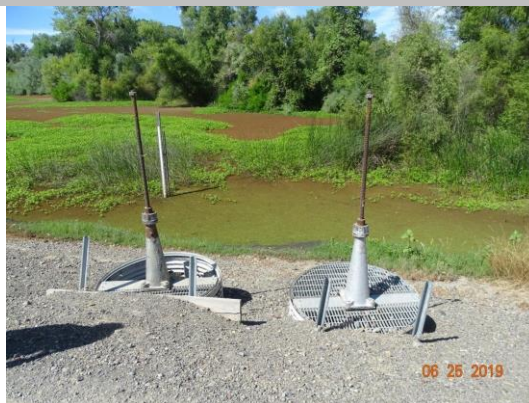
Photo 1 of 1 : ST\_2019\_NA0060\_17\_15\_20190701\_00021.jpg

LM Start	0.00	Rating **	A	Issue No.	15
LM End	0.00	Issue Type +	Ma	Location *	
Category	Pump Stations			GPS Latitude/Longitude	
				Start	End
Item	Sluice / Slide Gates			39.142300 °	39.142300 °
				-122.902350 °	-122.902350 °
DWR ID	DWR_NA0060_17_t_2013_15				
Action/Comments					
Inspector Comments: The slide gates are in good working condition.

View of the slide gates. Summer 2019.

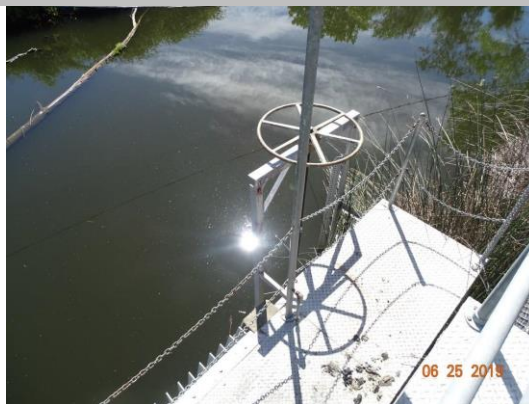
Photo 1 of 2 : ST\_2019\_NA0060\_17\_17\_20190701\_00022.jpg

LM Start	0.00	Rating **	A	Issue No.	17
LM End	0.00	Issue Type +	Ma	Location *	
Category	Pump Stations			GPS Latitude/Longitude	
				Start	End
Item	Manual Gate Operators			39.142300 °	39.142300 °
				-122.902350 °	-122.902350 °
DWR ID	DWR_NA0060_17_t_2012_17				
Action/Comments					
Inspector Comments: The manual gate operators are in good working condition.

View of a manual operator at the plant. Summer 2019.

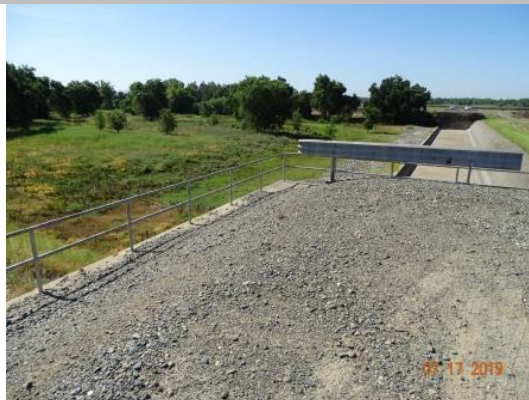
Photo 1 of 1 : ST\_2019\_NA0060\_4\_23\_20190718\_00027.jpg

LM Start	0.00	Rating **	A	Issue No.	23
LM End	0.00	Issue Type +	Ma	Location *	
Category	Structures & Concrete Lined Channels			GPS Latitude/Longitude	
				Start	End
Item	Safety			39.338242 °	39.338242 °
				-122.022073 °	-122.022073 °
DWR ID	DWR_NA0060_4_t_2012_23				
Action/Comments					
Inspector Comments: Adequate protection for fall hazards exist. No hazardous conditions that might affect the operation of the structure exist.

View of the safety and guard railing around the left bank abutment.

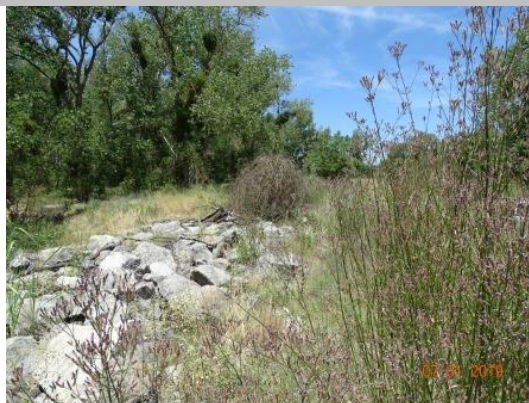
Photo 1 of 3 : ST\_2019\_NA0060\_54\_2\_20190708\_00006.jpg

LM Start	0.00	Rating **	M	Issue No.	2
LM End	0.00	Issue Type +	Ma	Location *	
Category	Structures & Concrete Lined Channels			GPS Latitude/Longitude	
				Start	End
Item	Vegetation & Obstructions			38.895500 °	38.887450 °
				-121.616950 °	-121.615330 °
DWR ID	DWR_NA0060_54_t_2012_2				
Action/Comments					
Inspector Comments: There is scattered obstructions or vegetation. The vegetation should be cleared and trees trimmed up. May impede flow in a high water event.

View of the vegetation that is overgrowing the rock weir looking north, 2019.

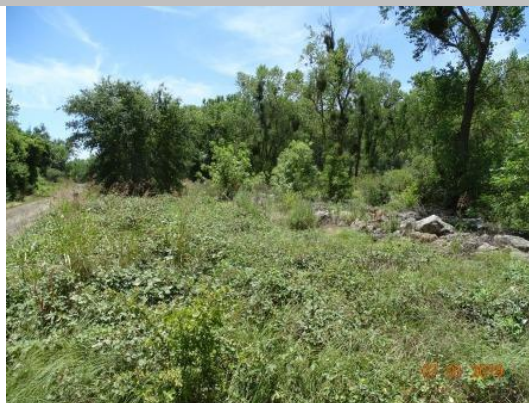
Photo 2 of 3 : ST\_2019\_NA0060\_54\_2\_20190708\_00007.jpg

LM Start	0.00	Rating **	M	Issue No.	2 (cont)	
LM End	0.00	Issue Type +	Ma	Location *		
Category	Structures & Concrete Lined Channels			GPS Latitude/Longitude		
				Start		End
Item	Vegetation & Obstructions			38.895500 °		38.887450 °
				-121.616950 °		-121.615330 °
DWR ID	DWR_NA0060_54_t_2012_2					
Action/Comments						
Inspector Comments: There is scattered obstructions or vegetation. The vegetation should be cleared and trees trimmed up. May impede flow in a high water event.

View of the vegetation that is overgrowing the rock weir looking south, 2019.

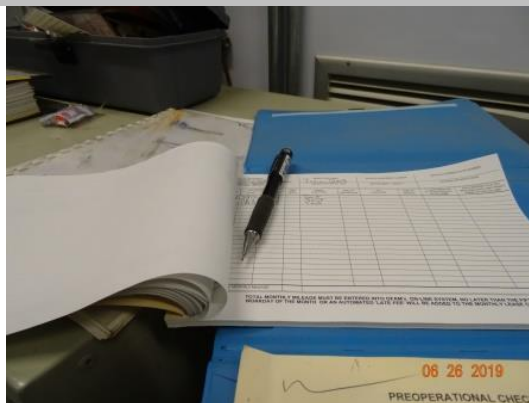
Photo 1 of 1 : ST\_2019\_NA0060\_21\_1\_20190627\_00039.jpg

LM Start	0.00	Rating **	A	Issue No.	1	
LM End	0.00	Issue Type +	Ma	Location *		
Category	Pump Stations			GPS Latitude/Longitude		
				Start	End	
Item	Operating Log			38.931815 °	38.931815 °	
				-121.634331 °	-121.634331 °	
DWR ID	DWR_NA0060_21_t_2012_1					
Action/Comments						
Inspector Comments: The operating log is kept on site.

View of operating log (Summer 2019).

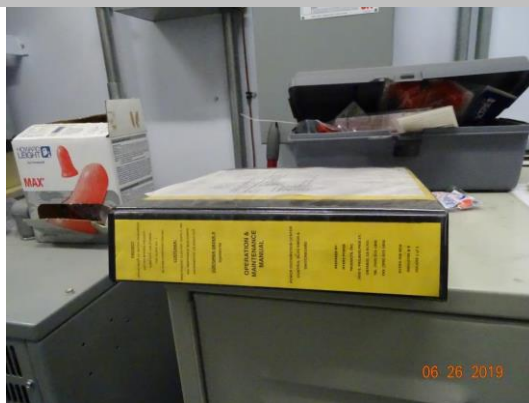
Photo 1 of 1 : ST\_2019\_NA0060\_21\_2\_20190626\_00020.jpg

LM Start	0.00	Rating **	A	Issue No.	2
LM End	0.00	Issue Type +	Ma	Location *	
Category	Pump Stations			GPS Latitude/Longitude	
				Start	End
Item	Operation & Maintenance Manual			38.931815 °	38.931815 °
				-121.634331 °	-121.634331 °
DWR ID	DWR_NA0060_21_t_2012_2				
Action/Comments					
Inspector Comments: The O&M manual is available at the site. Sutter Maintenance Yard will provide documentation of future maintenance.

View of O&amp;M Manual (Summer 2019).

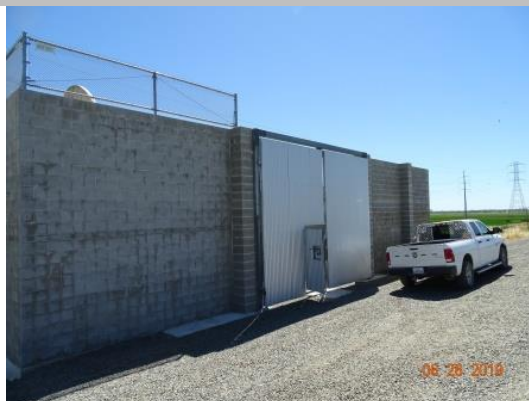
Photo 1 of 2 : ST\_2019\_NA0060\_21\_3\_20190627\_00040.jpg

LM Start	0.00	Rating **	A	Issue No.	3
LM End	0.00	Issue Type +	Ma	Location *	
Category	Pump Stations			GPS Latitude/Longitude	
				Start	End
Item	Plant Building			38.931815 °	38.931815 °
				-121.634331 °	-121.634331 °
DWR ID	DWR_NA0060_21_t_2012_3				
Action/Comments					
Inspector Comments: Plant building appears to be in good working order.

View of the outside of the facility. Photo taken June, 2019.

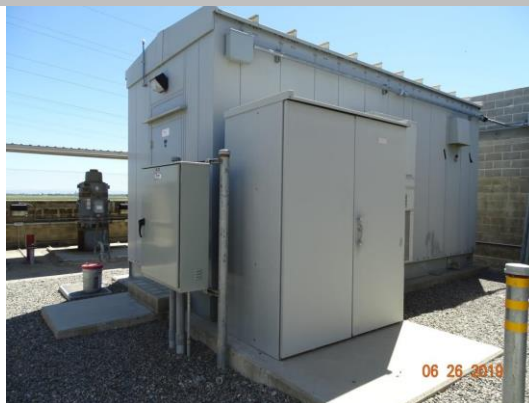
Photo 2 of 2 : ST\_2019\_NA0060\_21\_3\_20190626\_00022.jpg

LM Start	0.00	Rating **	A	Issue No.	3 (cont)	
LM End	0.00	Issue Type +	Ma	Location *		
Category	Pump Stations			GPS Latitude/Longitude		
				Start	End	
Item	Plant Building			38.931815 °	38.931815 °	
				-121.634331 °	-121.634331 °	
DWR ID	DWR_NA0060_21_t_2012_3					
Action/Comments						
Inspector Comments: Plant building appears to be in good working order.

View of the outside of the operating building. Photo taken June, 2019.

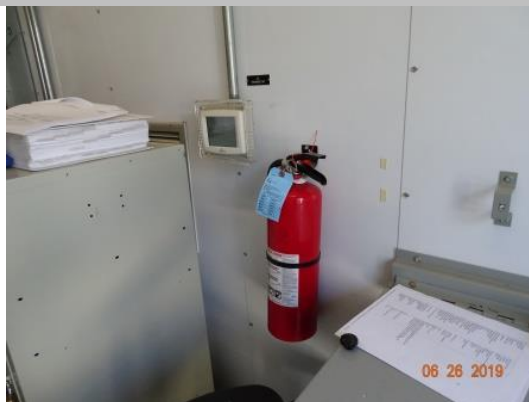
Photo 1 of 7 : ST\_2019\_NA0060\_21\_5\_20190627\_00041.jpg

LM Start	0.00	Rating **	A	Issue No.	5
LM End	0.00	Issue Type +	Ma	Location *	
Category	Pump Stations			GPS Latitude/Longitude	
				Start	End
Item	Safety			38.931815 °	38.931815 °
				-121.634331 °	-121.634331 °
DWR ID	DWR_NA0060_21_t_2012_5				
Action/Comments					
Inspector Comments: All safety gear is in place and in working order.

View of fire extinguisher inside the operating room (Summer 2019).

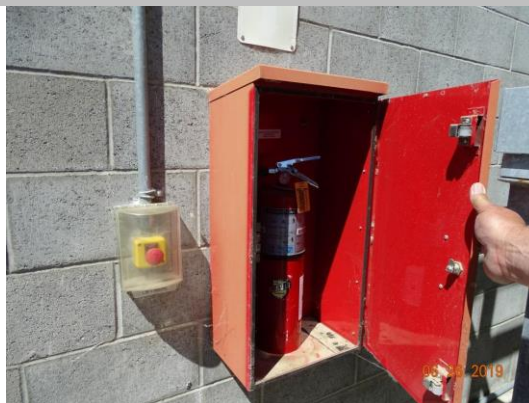
Photo 2 of 7 : ST\_2019\_NA0060\_21\_5\_20190626\_00024.jpg

LM Start	0.00	Rating **	A	Issue No.	5 (cont)	
LM End	0.00	Issue Type +	Ma	Location *		
Category	Pump Stations			GPS Latitude/Longitude		
				Start	End	
Item	Safety			38.931815 °	38.931815 °	
				-121.634331 °	-121.634331 °	
DWR ID	DWR_NA0060_21_t_2012_5					
Action/Comments						
Inspector Comments: All safety gear is in place and in working order.

View of fire extinguisher next to facility entrance (Summer 2019).

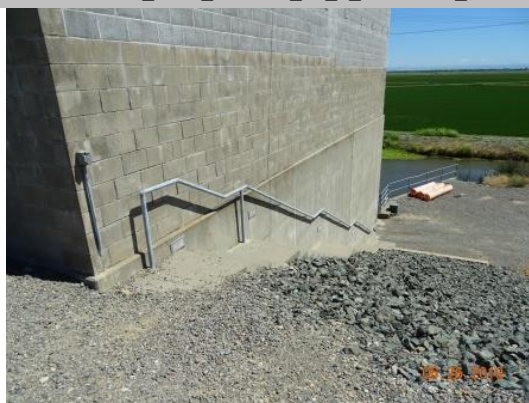
Photo 3 of 7 : ST\_2019\_NA0060\_21\_5\_20190627\_00042.jpg

View of stairway railing leading down to pump inlet (Summer 2019).

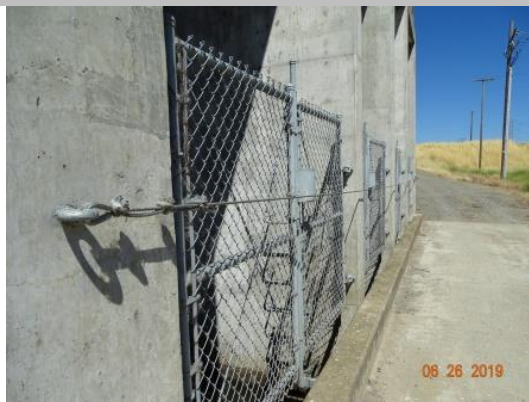
Photo 4 of 7 : ST\_2019\_NA0060\_21\_5\_20190627\_00043.jpg

View of fall protection cable hook-in next to wet wells (Summer 2019).

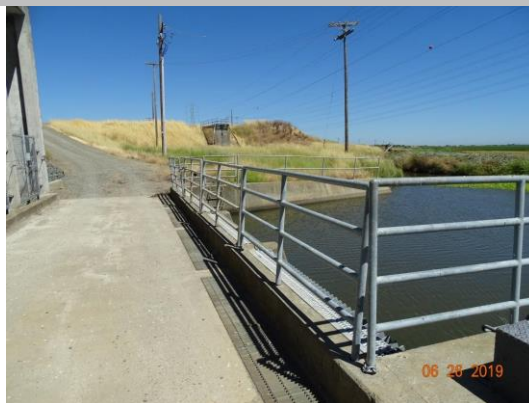
Photo 5 of 7 : ST\_2019\_NA0060\_21\_5\_20190626\_00027.jpg

View of railings above the trash racks (Summer 2019).

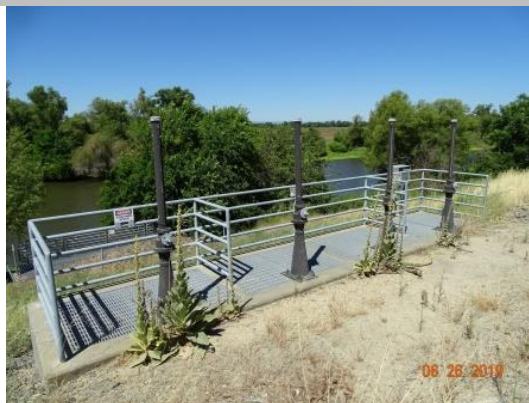
Photo 6 of 7 : ST\_2019\_NA0060\_21\_5\_20190627\_00044.jpg

View of railings next to manual gate operators (Summer 2019).

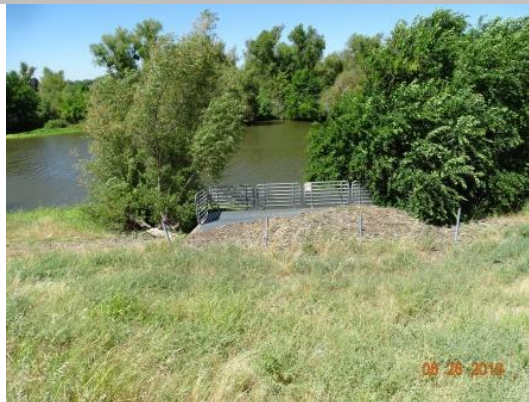
Photo 7 of 7 : ST\_2019\_NA0060\_21\_5\_20190627\_00045.jpg

View of railings next to flap gate gate (Summer 2019).
